Research Summary

Nondestructive Evaluation of MoDOT Bridge Decks – Pilot Study

REPORT NUMBER: cmr14-010

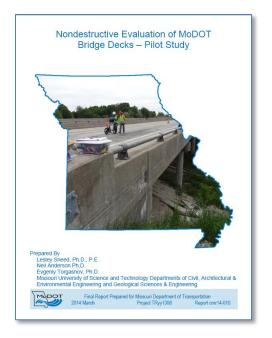
Ground Coupled GPR Scanning

Ground coupled GPR measures the response of radar pulses from the surface of bridge deck rebar to determine the level of deterioration of the concrete above the rebar. Deterioration in the concrete causes distortions and a change in amplitude of the GPR signal. From this information, a map of the bridge deck deterioration can be created.
